OT-2 Test Report

Draft 12/8/04 CSW

Draft Ralph Optical Test 2 (OT2) Report

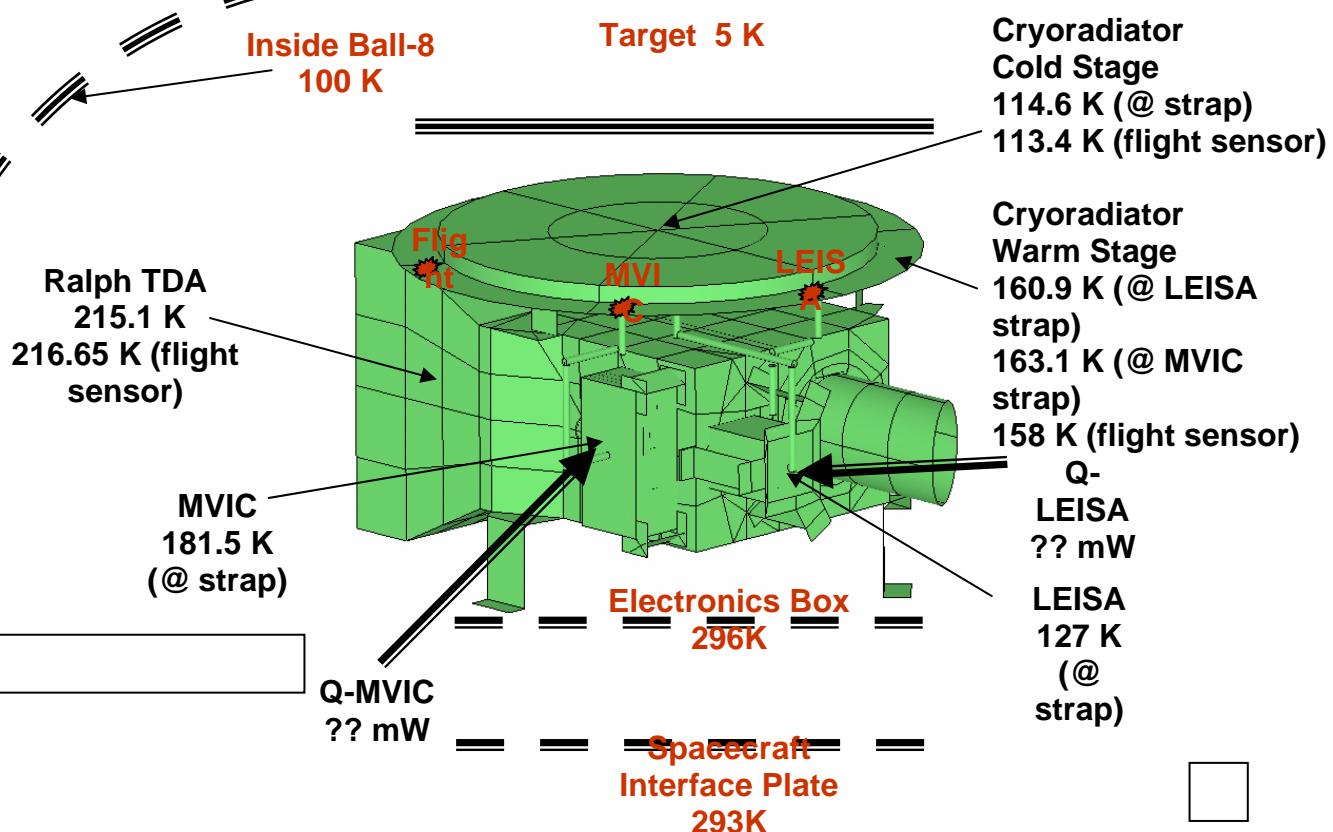
The thermal performance of the Ralph instrument during OT2 did not agree with model predictions. This included that the flight detectors did not reach their required operating temperatures. LEISA measured 10 K higher than predicted (127 K vs. 117 K) and MVIC measured 14.5 K higher (181.5 K vs. 167 K). MVIC did not reach its predicted value but was within specification.

The reasons for the discrepancies have been enumerated in the SER and a plan for correcting them is in process. If left uncorrected, the identified problems in the flight design would result in LEISA meeting its thermal requirements with zero thermal margin. This is viewed as an unacceptable risk on account of error inherent to the model.

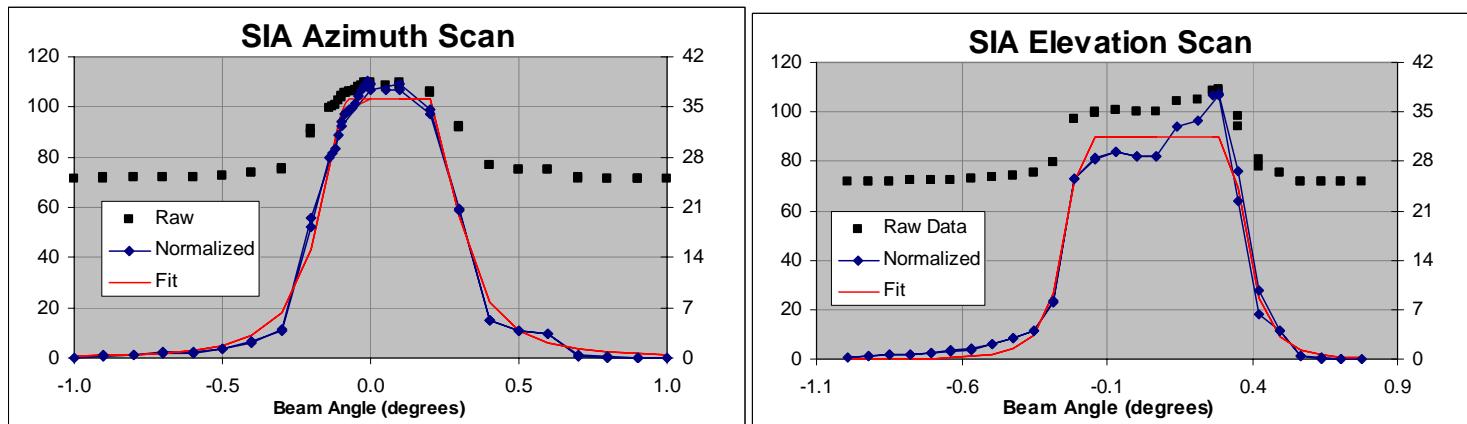
Azimuth and Elevation scans of the SIA input angle yielded repeatable values of 0.490° and 0.634° , respectively. The expected input angles by design are both 0.63° . The reason the azimuth scan is less than expected is believed to be due to the scan not being centered, this needs to be confirmed. However, it should not impact its application.

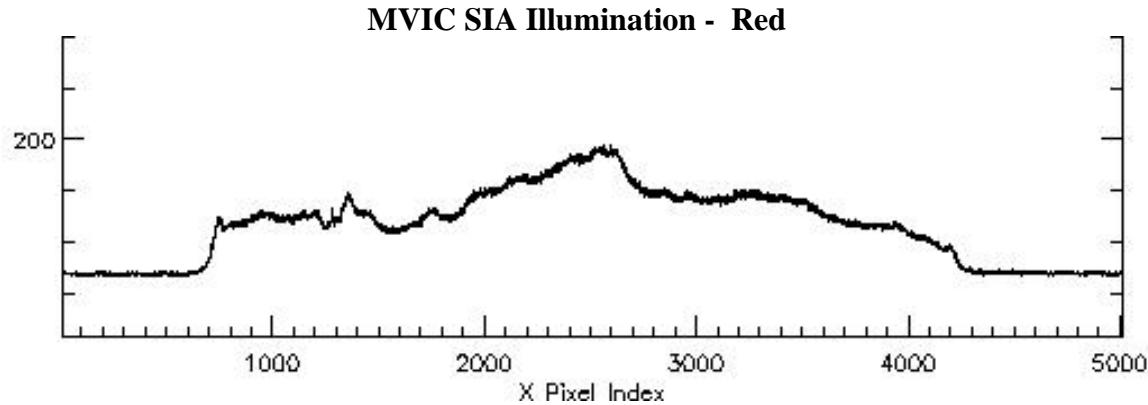
Below is an example of the illumination amplitude measured on the MVIC Red array. Variations in the measured signal amplitude can be seen, this is the “field flatness”. This includes here not only the optical effects associated with the SIA itself, but also filter transmission, detector pixel-to-pixel uniformity, and noise. The basic patterns can be seen in the images themselves and were observed to be stable between OT2 and OT2B/C. In addition it can be seen that the illumination did not extend to the edges of the array, but drop to the 40 count offset well within the 5000 pixel width of the array. This was observed on all of the MVIC arrays and is suspected to result from a manufacturing error in the SIA. The addition of a lens to the output coupler by the vendor had the effect of reducing the overall diameter of the illuminated circle to less than that required to fully illuminate all MVIC arrays. This can only be corrected by rework of the SIA within the TDA.

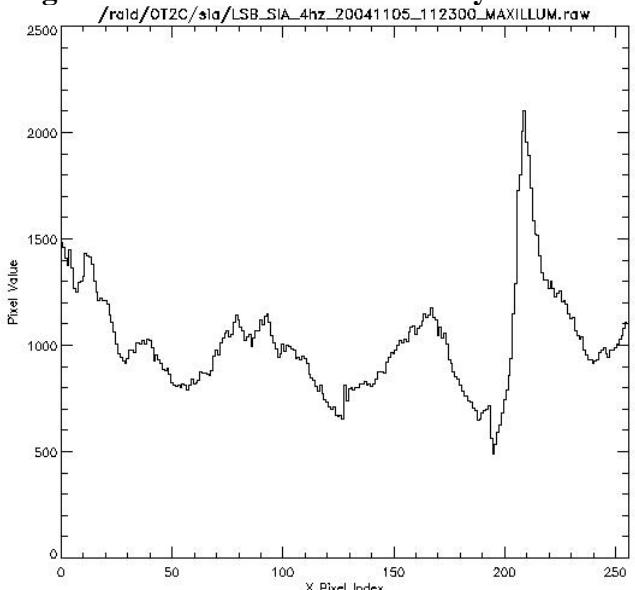
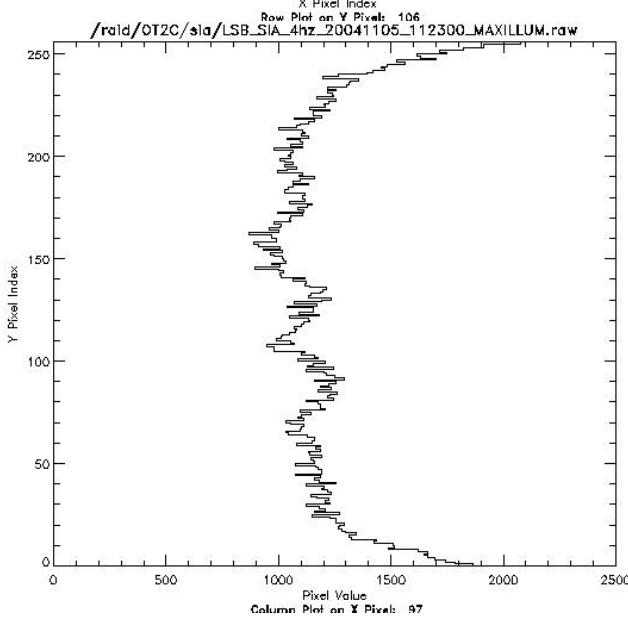
Signal from LEISA Illuminated by SIA

The peak in the signal near column X=200 is believed to be due to the physical edge in the LEISA etalon filter. For the signal along a column, the rise in the signal at the edges (Y = 256 and Y = 0) is not understood at this time, but similar results were found when the detector was illuminated by a flat field through the main aperture (see Section 8)

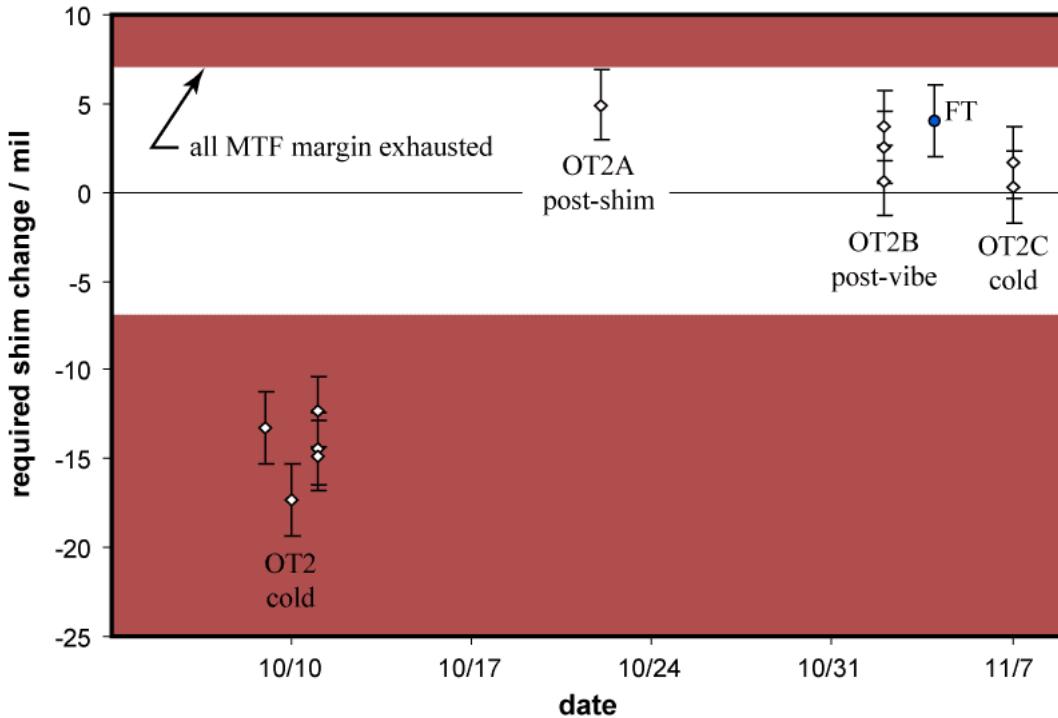
MVIC focus trends

To ensure that best focus would be obtained at the detectors' physical locations, a series of measurements was made throughout the development of the TDA and detectors to track dimensions and changes that were made. Despite this, the first OT2 measurements found that both MVIC and LEISA detectors were not located at best focus. MVIC was sufficiently out of focus that the models predicted that it would not meet its MTF (Modulation Transfer Function) requirement on image quality. LEISA has no equivalent requirement.

Based on the measurements a new shim value for MVIC was calculated and installed. Shim replacement does not require removal of the detector package. The focus was then re-measured in OT2A at room temperature. The results of OT1 and OT2 both showed that the TDA optical design was sufficiently athermal that there was no significant focal shift going from room temperature to nominal operating temperatures for MVIC. This was confirmed again in OT2. (Focus cannot be measured on LEISA at room temperature on account of degraded noise/responsivity performance). A graph showing the MVIC trend during OT2 compared with its derived requirement is shown below. The shim operation is seen to have brought MVIC within its requirement and no statistically significant shift of the focus occurred in going through vibration testing. The error bars in the graph estimate systematic and random errors in the optical measurement set-up. FT here stands for a measurement made on the frame transfer array, the other measurements all being made on pan (or in one case red) arrays.

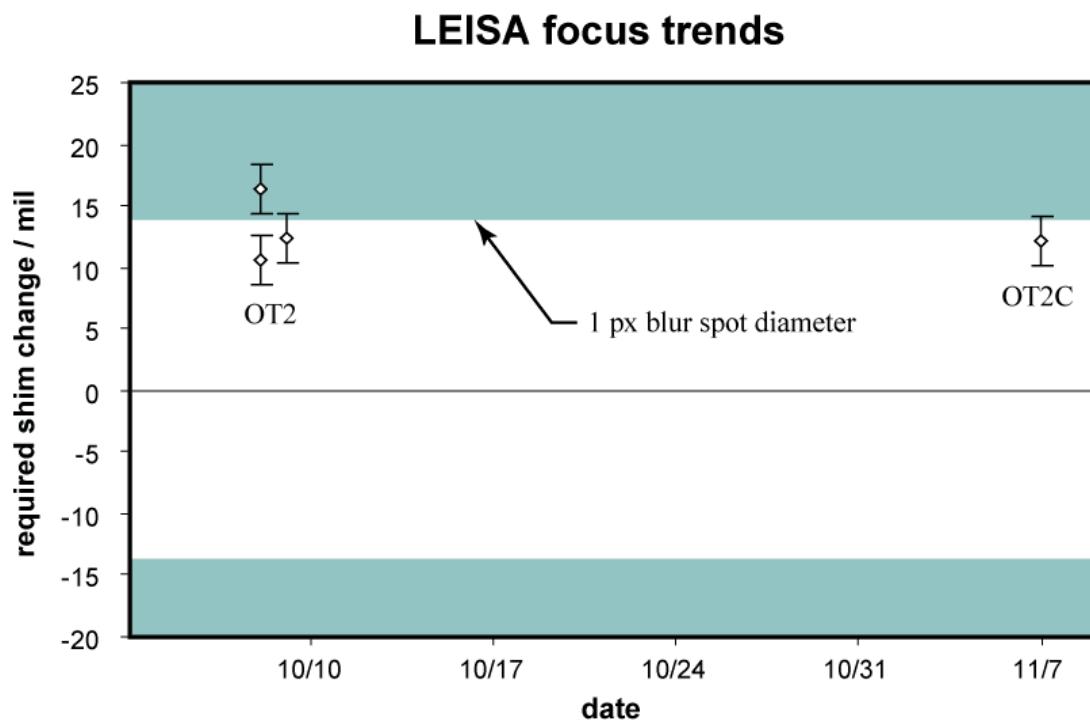
No shim correction was made on the LEISA detector. The trend chart below shows that the installed shim met the goal of having a one pixel spot blur diameter. Note again, LEISA focus data could only be collected at cryogenic temperatures.

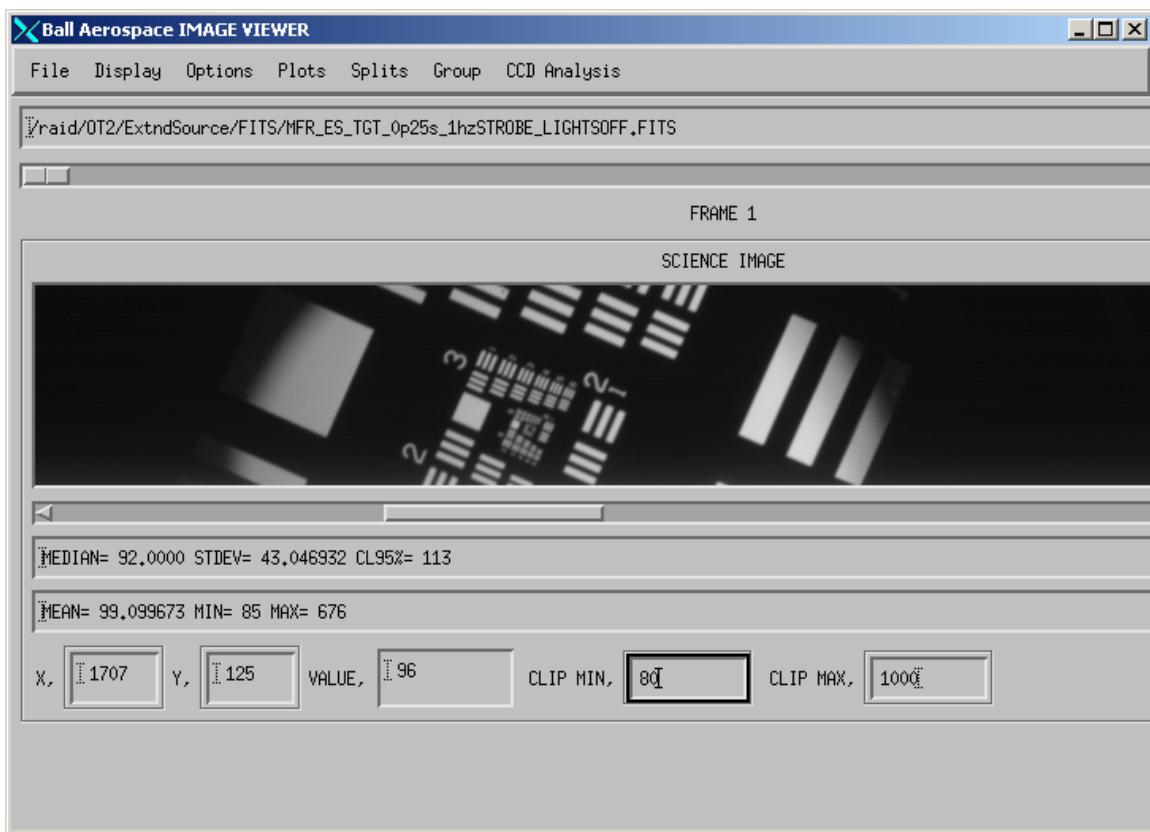
Figure MVIC-1: Frame image of Air Force standard target. Note that our “hard zero” problem does not occur at the bottom of this frame image.

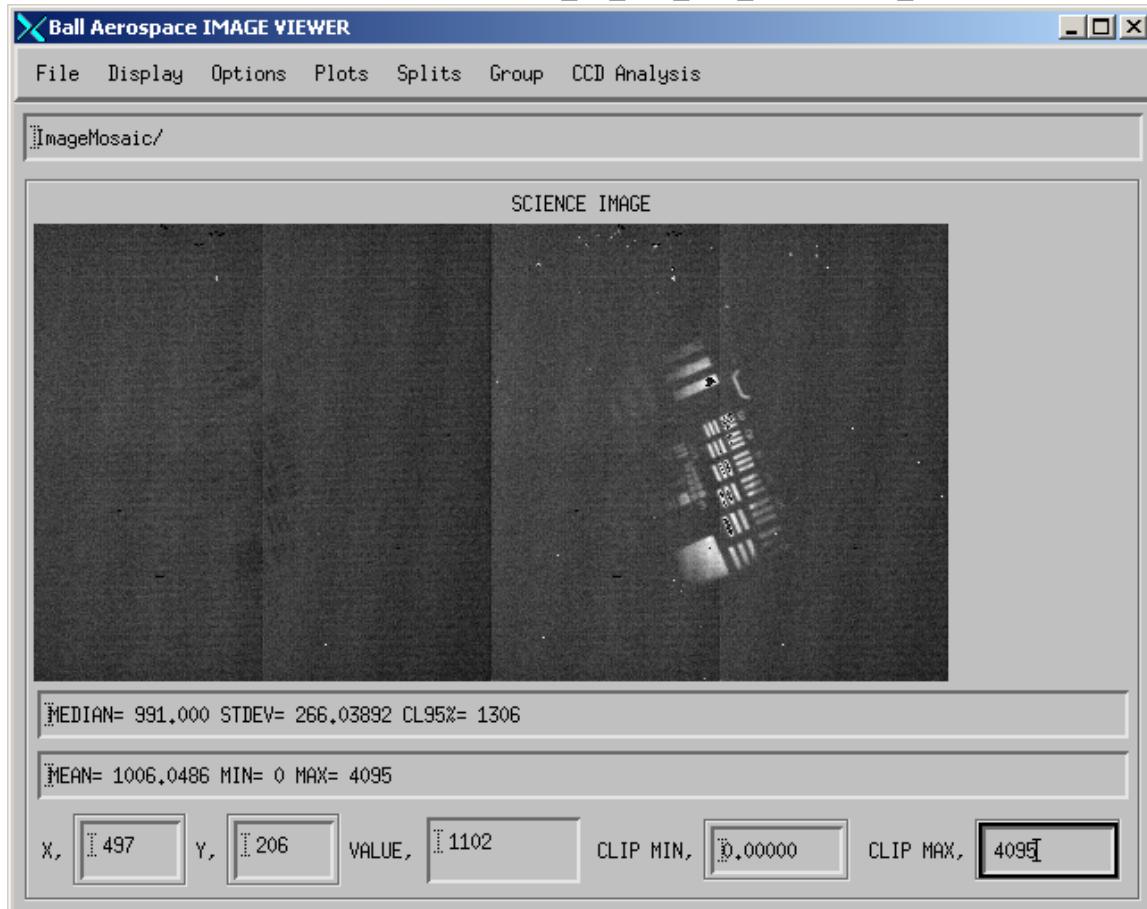
Figure LEISA-1: reset (L) and read (R) images showing the target pattern (R) and a faint negative image of the bright target on the reset image.

Such negative images (as seen on left) are routinely observed on Spitzer array reset images after saturation by a bright source. The amplitude of the negative image is at most 200 DN after saturation (see black pixels in R image). Quantitative analysis of this effect on radiometric accuracy for time-varying scenes is TBD.

Note fade on L side of R image as filter throughput and fiber-optic source output decrease.

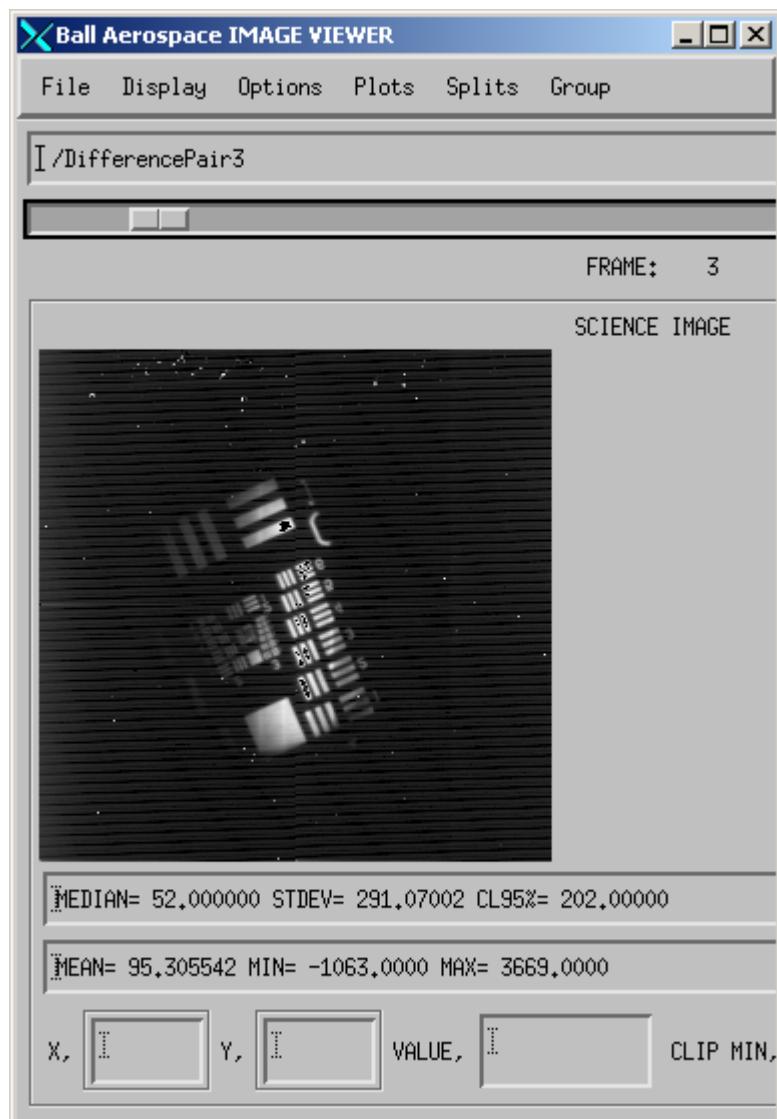
Figure LEISA-2: Same as Figure LEISA-1. This is a read-reset image, square root scaled to bring out detail. Black pixels in illuminated areas are the ADC wraparound and may be restored by adding 4096 to the pixel value.

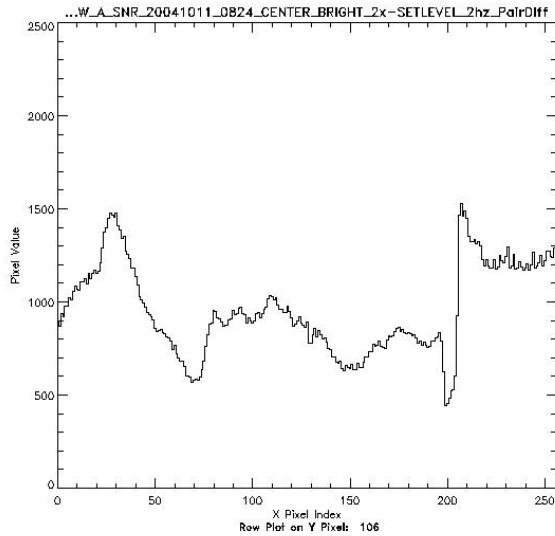
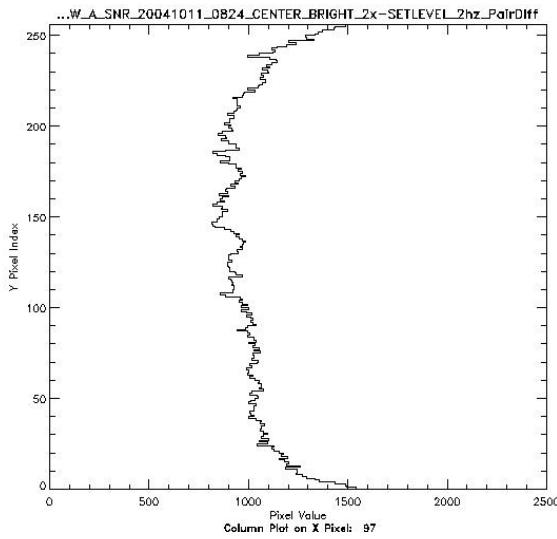
LEISA Signal while Illuminated by Sphere

Note the appearance again of the edge in the LEISA etalon near $X = 200$, and the rise in the signal near the $Y = 0$ and 256 edges.

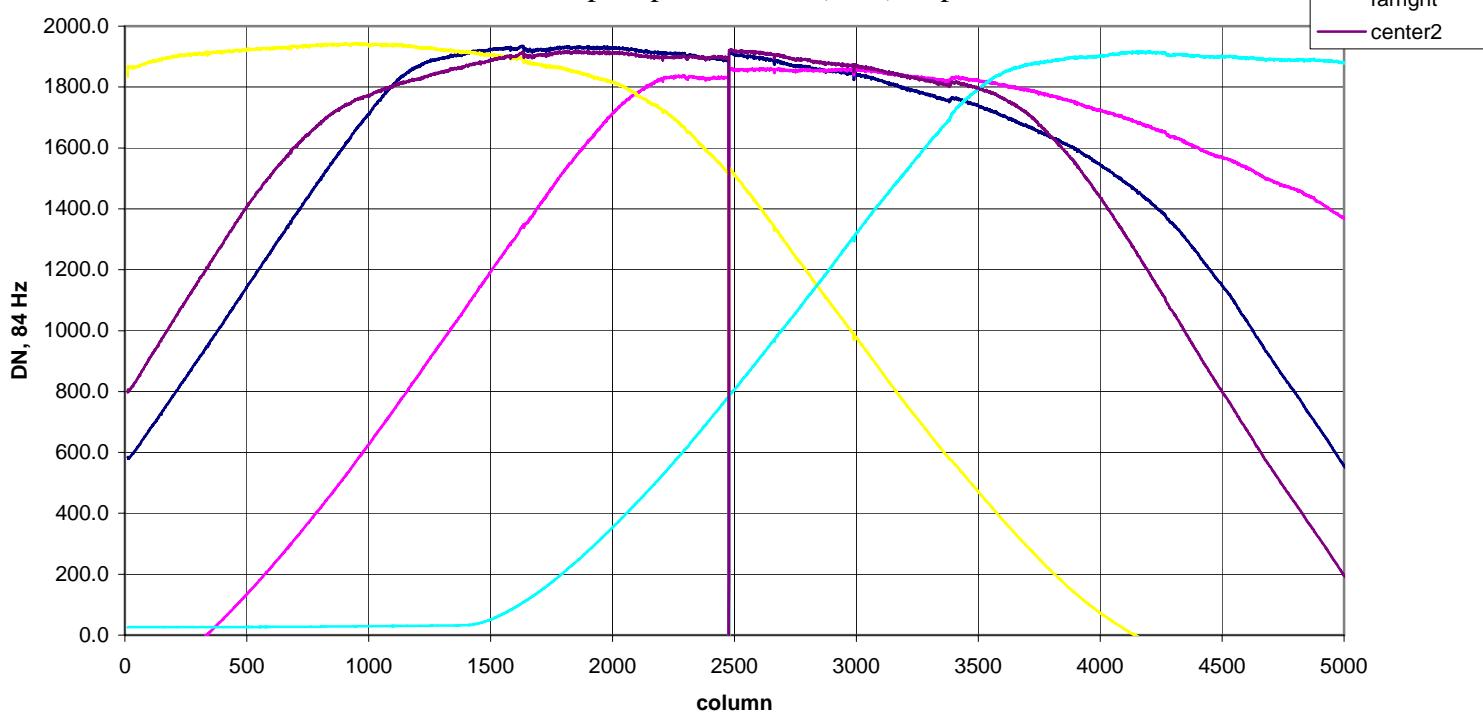
The center location was taken twice. The first time yielded an anomalously low value (requiring multiplication by 1.5 to scale) and an odd shape. The data was then retaken slightly offset from the first.. The vertical line going to zero near the center is a documented FPGA problem. The graphs illustrate that there is very little structure in the MVIC data. This means that for Pan1 the illumination, optical transmission, and detector responsivity are relatively flat.

Note that the MVIC arrays cannot be fully illuminated on account of vignetting at the Ball 8 vacuum window and cryoflat mirror. By moving the center of illumination it can be seen that there is no evidence of significant vignetting in the flight hardware, the edges of the array can be illuminated with resulting light levels similar to at the center of the array.

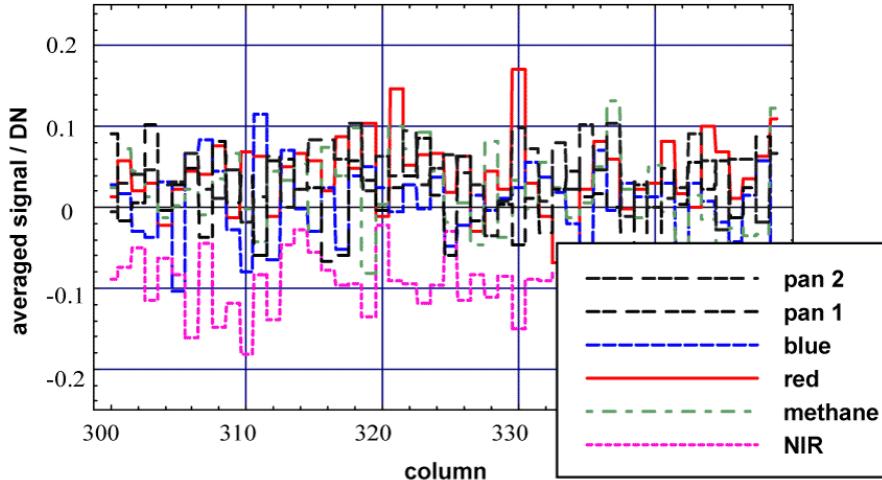
out-of-field illumination

corrected for dark baseline. The results are consistent with the baseline noise, therefore there is no indication of scattered light.
