OT-2 Test Report

Draft 12/8/04 CSW

Draft Ralph Optical Test 2 (OT2) Report

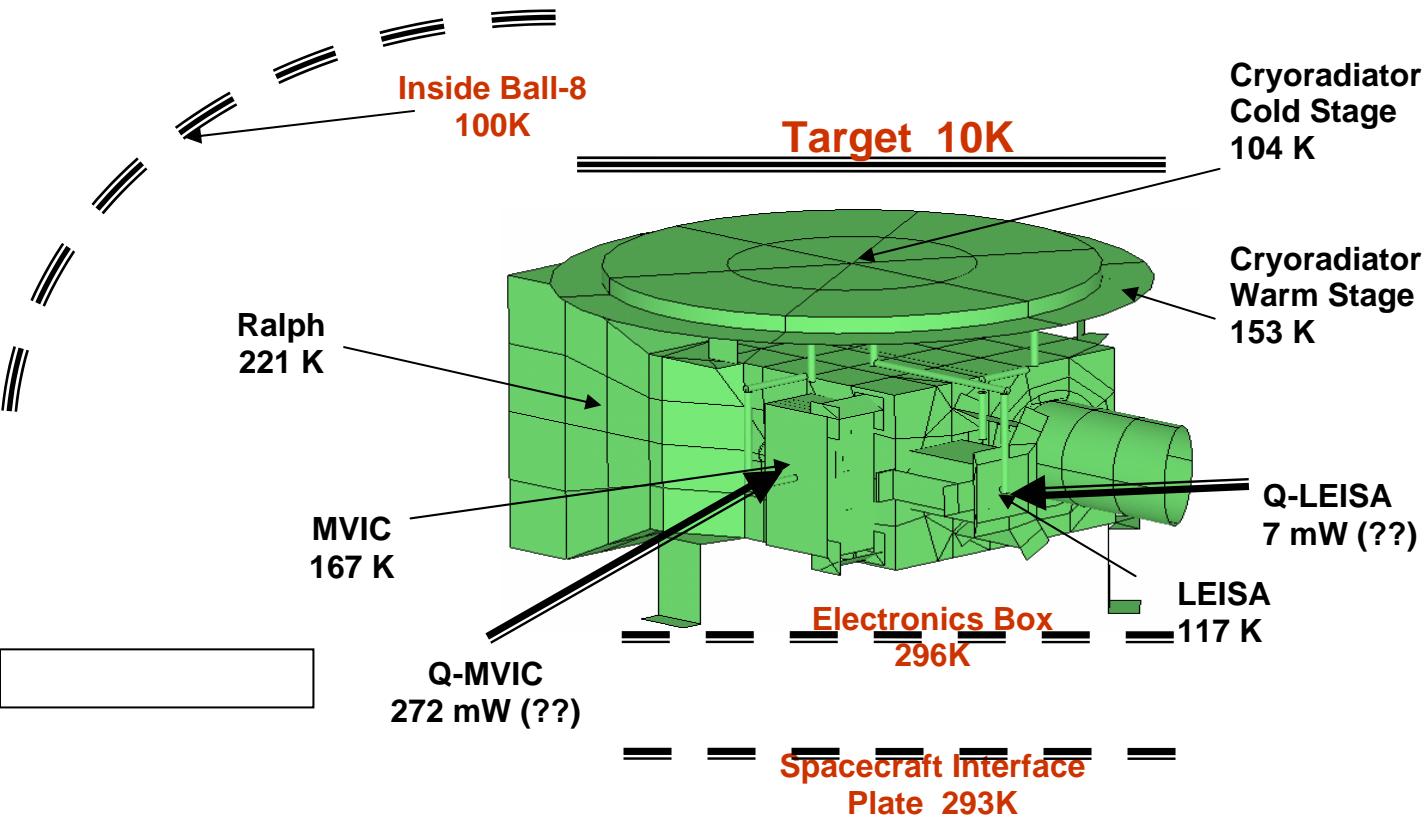
The thermal performance of the Ralph instrument during OT2 did not agree with model predictions. This included that the flight detectors did not reach their required operating temperatures. LEISA measured 10 K higher than predicted (127 K vs. 117 K) and MVIC measured 14.5 K higher (181.5 K vs. 167 K). MVIC did not reach its predicted value but was within specification.

The following figure shows the predicted OT2 temperatures (see Hardaway SER# 2219150):

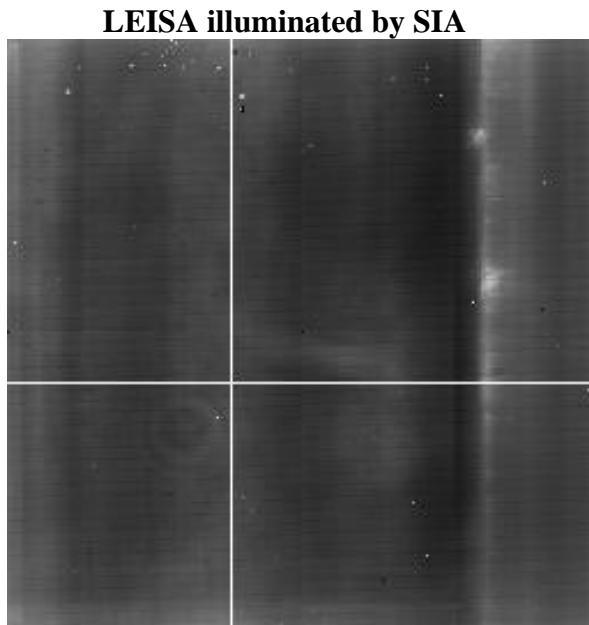
Signal from LEISA Illuminated by SIA

The LEISA array was fully illuminated by the SIA despite the design flaw because of its smaller field-of-view. Below is an example of the results of LEISA illuminated by the SIA. The vertical and horizontal white lines have been added to show where the following line plots are collected. Comparing the images where the detectors were illuminated with the SIA (below) and through the primary aperture (Section 8) shows that the dominant structure comes from the filter/arrays themselves. However intensity rings that occurred in the SIA images on MVIC and LEISA were not observed in the data taken through the main aperture and therefore must be SIA effects.

The peak in the signal near column X=200 is believed to be due to the physical edge in the LEISA etalon filter. For the signal along a column, the rise in the signal at the edges (Y = 256 and Y = 0) is not understood at this time, but similar results were found when the detector was illuminated by a flat field through the main aperture (see Section 8)

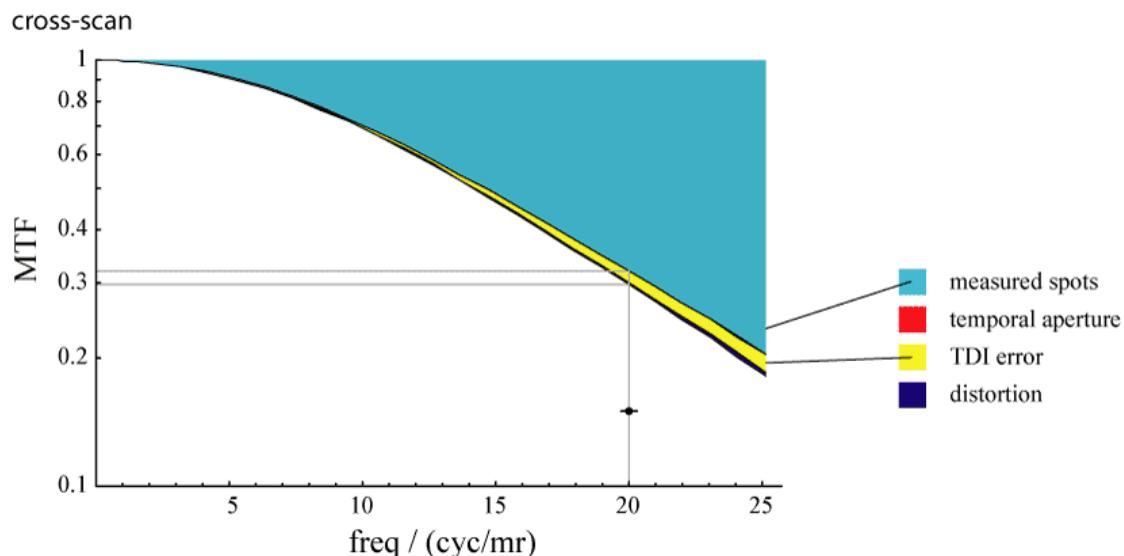
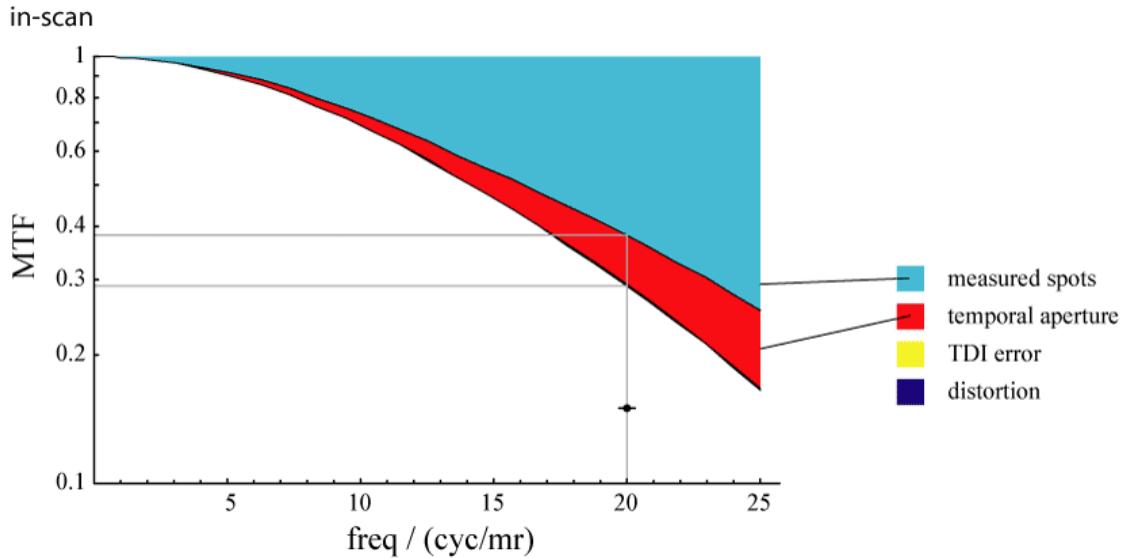
There are many measures of optical image quality. The Ralph Instrument Specification uses the Modulation Transfer Function (MTF) for MVIC. Specifically, “the MTF for data obtained using the TDI data acquisition shall be ≥ 0.15 at 0.020 cycles/ μ rad for all wavelength bands”. The MTF is calculated from measurements on the spot size at focus (Sabatke SER 2216317). The calculated values are combined with modeled values of other effects (see Sabatke SER # 2203452) to give a predicted worst-case in-flight performance. This is shown below for both the cross-scan and in-scan directions. The graphs show that the MVIC can meet its MTF requirement (shown as a dot) with significant margin.

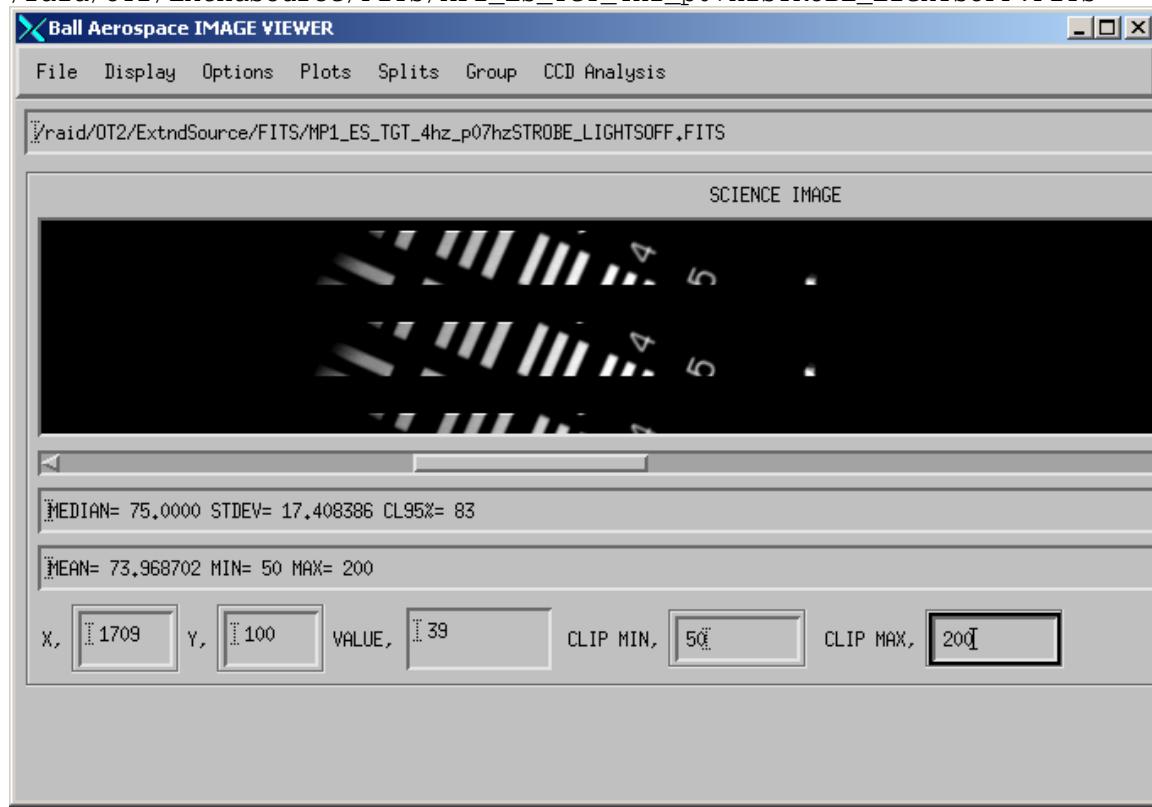
Figure MVIC-2: Pan1 image showing Air Force test target illuminated by strobe to freeze pattern on TDI array.

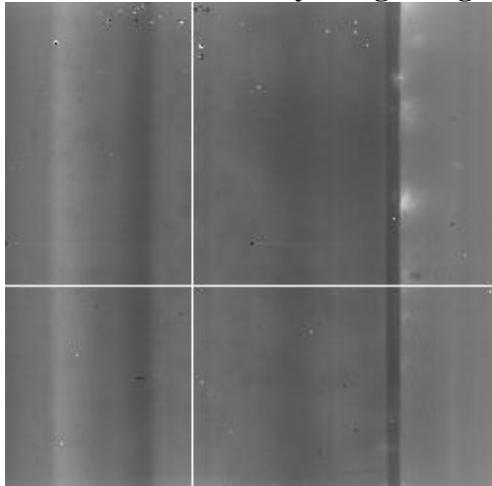
LEISA Illuminated by Integrating Sphere

With LEISA illuminated through the main aperture with the integrating sphere, an image was collected and line plots taken along the row and column marked with white lines. Note that these are the same row/column used for the SIA example in Section 4. No intensity “rings” were observed in this data in contrast to the SIA data.

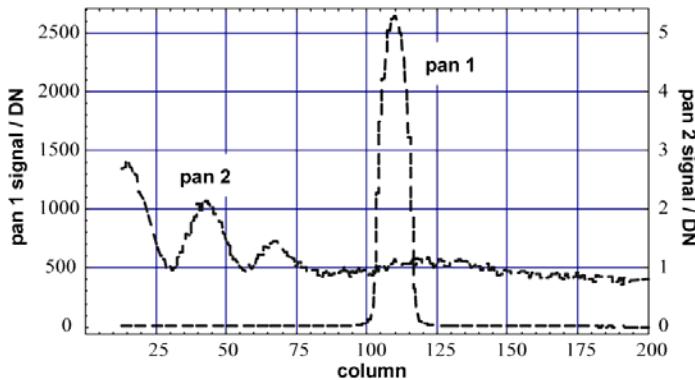
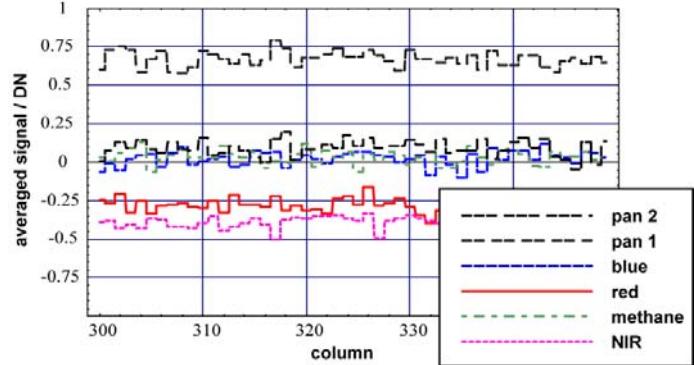
in-field illumination

A test for this was performed during OT2 and the data analysis done by Derek Sabatke. The test was done by first illuminating MVIC pan1 through a 2" diameter aperture aligned within the field of view to give a baseline for the source light intensity. Neutral density filters giving a total attenuation factor of $10^{-4.5}$ were installed to prevent saturation. The first of the following graphs show that there is no significant leakage either optically or electrically from pan1 to pan2 at the same column location when pan1 is strongly illuminated. Similarly, there is no leakage from the strongly illuminated pan1 (spot at column 110) to the other detectors in offset columns (300-350)

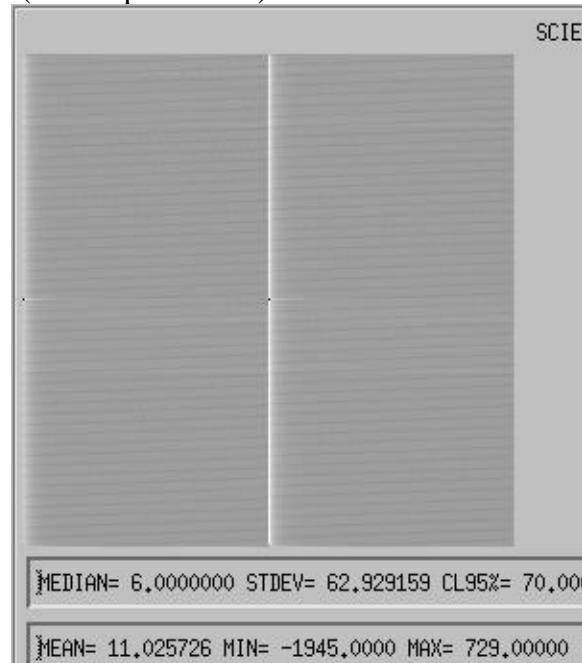
The differenced image (for the pair above) is shown below:

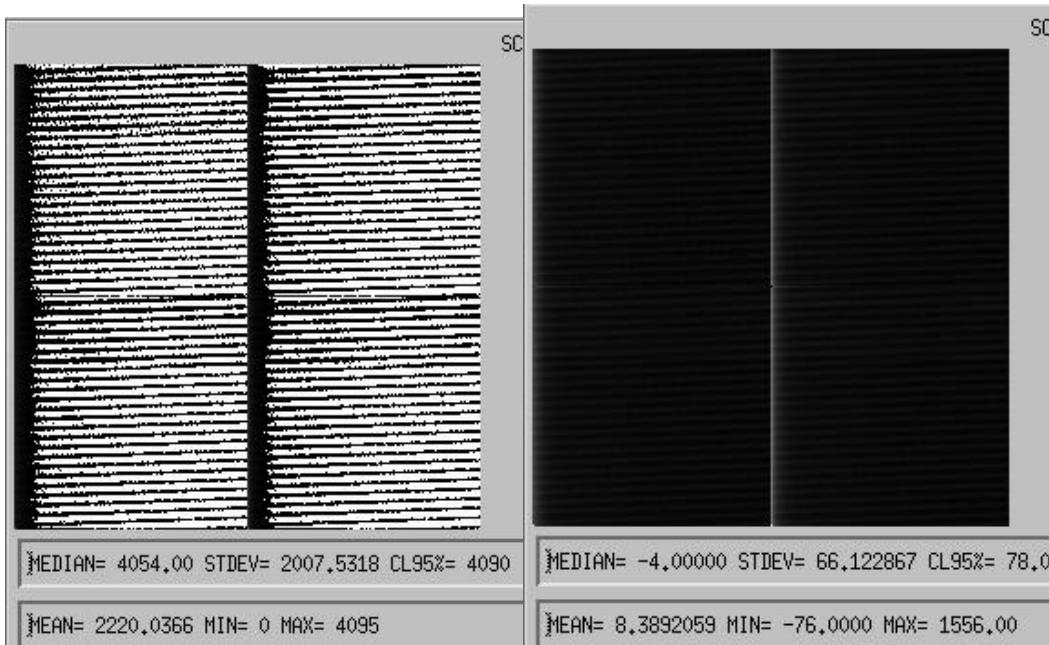
LEISA subtracted images, as shown below (LSB_A_8p0_20041002_145611.raw) are correctable to show detector details:

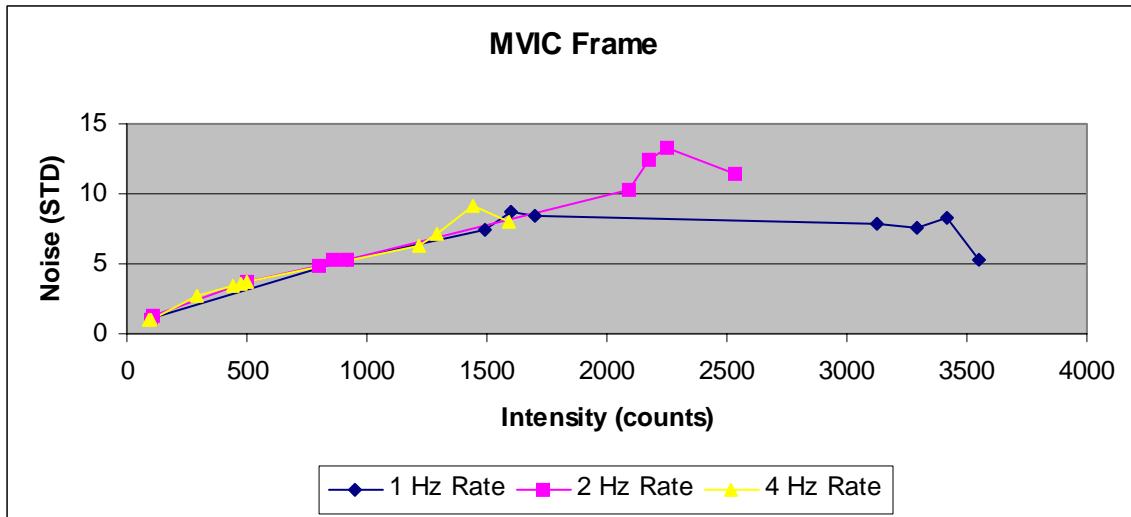
MVIC Pan Frame data was taken at 3 data rates. The portion of the images which were evenly illuminated were extracted and rows below 43 were deleted due to the roll off and potential FPGA problem in that area. Data was analyzed using group statistics to produce the mean illumination (counts) and mean STD. These values were then plotted to show the effect of illumination levels on the noise measurements. The 1 Hz data shows the effect of saturation at high signal levels.

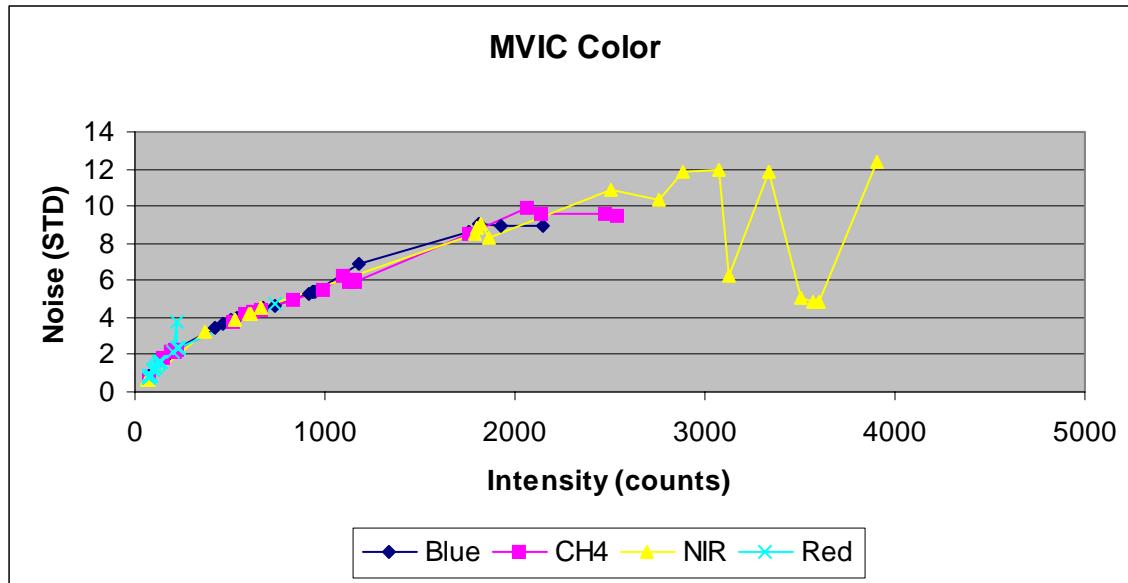
MVIC Color data was taken at 54.9hz with lower rates saturating. The portion of the images which were evenly illuminated were extracted and analyzed using column statistics to produce the mean illumination (counts) and mean STD. These values were then plotted to show the effect of illumination levels on the noise measurements. Again, saturation effects are seen at high signal levels.
