The Atsa 1 Camera: Current Status

Abstract

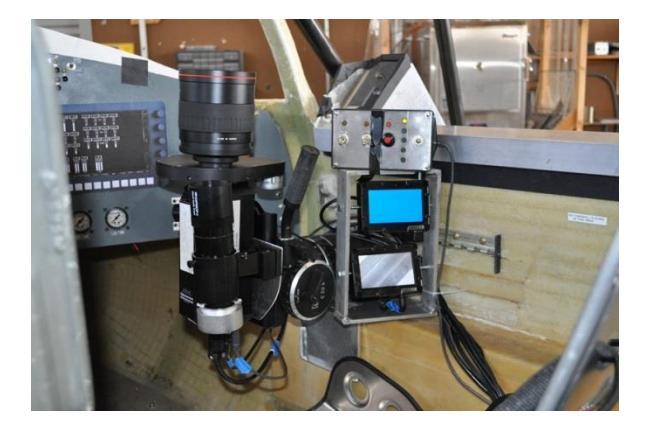
spacecraft in August. A successful fit was achieved (see figure), and the system was successfully operated from the cockpit. The team developed checklists for the installation and removal of the system, as well as for ingress and egress of the telescope operator. The system was also examined by an XCOR test pilot and by a safety officer.

Figure 1. The Atsa 1 Camera in the Lynx cockpit testbed

As a result of the fit-testing, we are re-configuring the camera to sit higher in the cockpit than in the figure, and building a smaller control box (which will also move from its current position). We are going to replace our fore-optic with a small research-grade telescope (though which one is to be determined); we will also include a truss in the next iteration of the Atsa 1 Camera to hold the optical elements in proper alignment through launch.
